# Analysis and Improvement Practice for Steam Control Valve Stem Fracture of Back Pressure Steam Turbine

CNOOC HuiZhou Petrochemical Co.Ltd., Huizhou, 516086, China

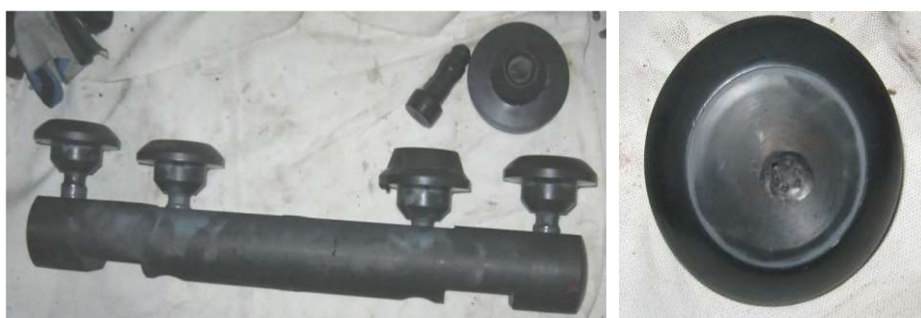
While the pressure of steam system was recovering, the opening of the steam control valve of the steam turbine was gradually to reduced automatically, but on the way of steam system recovered to normal, it was found that the speed of the compressor turbine could only be held above 8300 rpm, could not came down below 8300 rpm, whether manual model or automatic model. Finally, unwillingly, it was stopped by activating the fast-shutdown valve. After checked the control instruments, oil motor, hydraulic cylinder, secondary oil pressure, regulating valve level rod, etc., no abnormality problem was found, so it was preliminary judged that a valve disc of the steam valve assembly had fallen off. After disassembly, we found that the V-valve stem was broken, and the breaking location was at the end of the screw thread, and the hexagon head of the stem nut had been damaged with round friction , as shown in Figure 2. In order to reduce the impact of process, the damaged V-valve stem replaced and the II valve disc (slight damaged) were repaired and assembled again, and then, the compressor was restarted without problem. At meantime the original supplier was notified and they transported a set of V-valve stem and disc by air as urgent spare parts to be stored.

**Figure 2.** V-Valve Stem Fracture and II-Valve Disc Scar

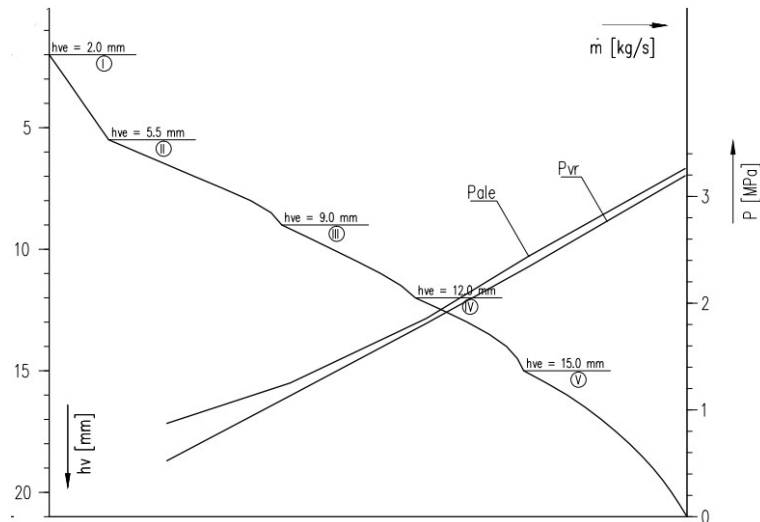
According to the analysis, the speed of 8300 rpm was in the control region of the V-valve, while the valve controller output was on closing stroke, the V-valve disc could not moved to the seat because it was stuck, of course it had deducted the noneffective stroke, show Figure 3, so the steam flow and the speed had no decrease.

**Figure 3.** Action Sequence and noneffective stroke height of Steam control Valve

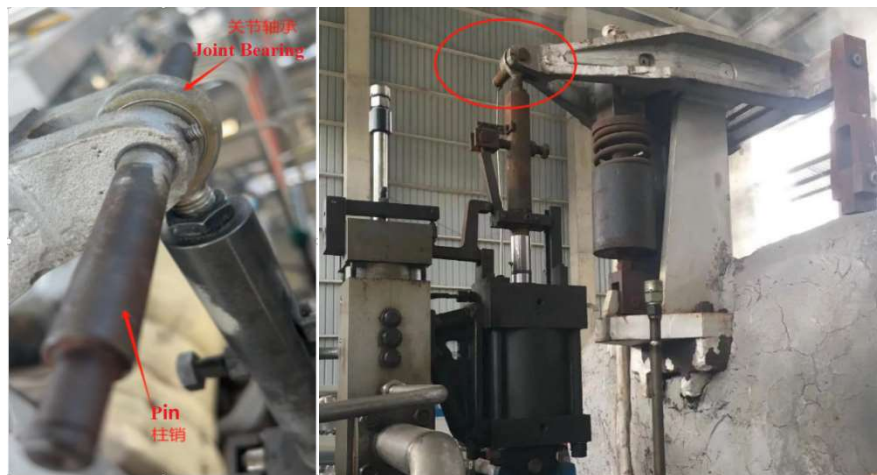
Fifth months later, the compressor stopped without any prior alarm messages. It was found that the the speed-regulating connecting rod and the hydraulic cylinder piston was separated off, and the failure caused the control valve closed by spring force. See Figure 4. Further inspection revealed that there were no dowel hole be made and therefore no anti-slip cotter pins were installed. After the problem was confirmed, the connecting rod mechanism was reconnected, and the points which were easy to slip were welded together, to prevent the hydraulic piston rod to have rotating movement.

**Figure 4.** Connecting Rod of Hydraulic Piston to Transmission Mechanism

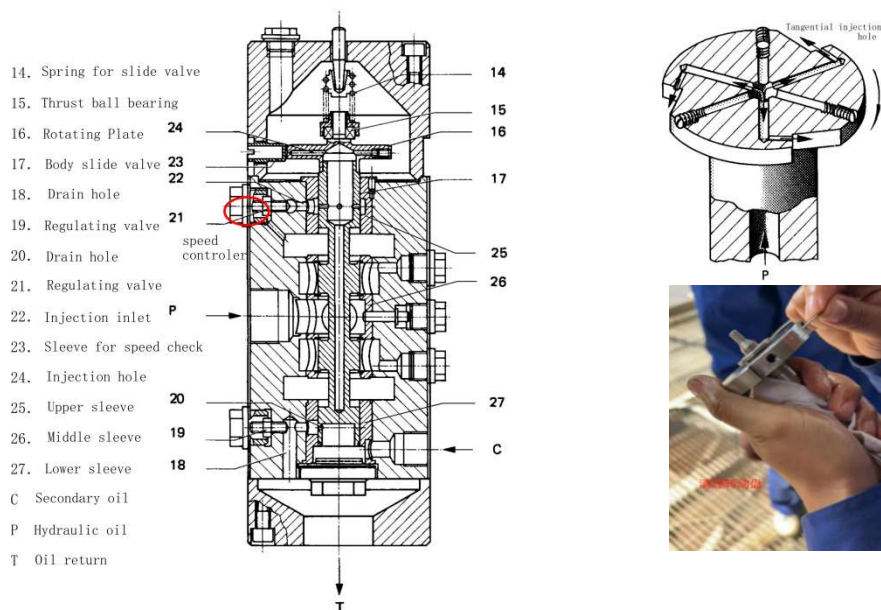
of the three tangential oil injection holes was blocked by some slag inclusion. When pressure oil enters the central chamber of the slide valve from the oil inlet hole, and then squirts out from the three radial and tangential oil injection holes of the rotating plate. Under the action of tangential force, the slide valve continuously rotates, the torque depends on the amount of oil injection, and the speed of the slide valve can be adjusted by means of the regulating valve. The recommended working speed of the slide valve is 300 ~ 800 r/min. After cleaning the rotating plate of the slide valve, the rotating speed oscillation disappears and PID can be controlled normally.

Figure 5. Sketch of Rotating Plate

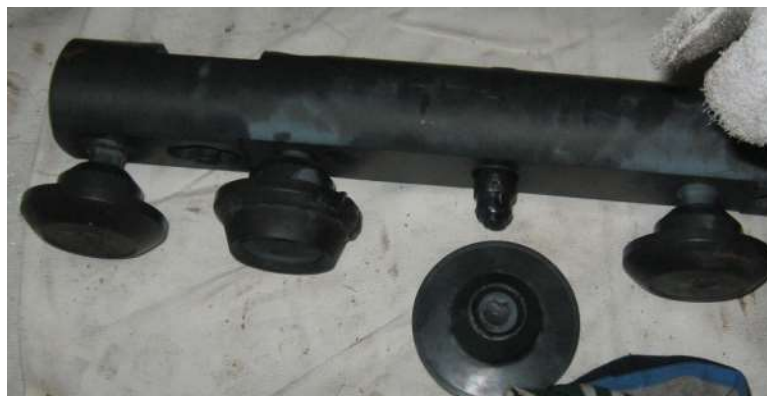
After the compressor ran again for 1 month, the plant was stopped to take a planned turnaround. During the shutdown procedure, the compressor was found that the turbine speed could not to reduce when it was reduced to 4000 rpm, even the hydraulic cylinder of the speed control valve was gradually fully extended. According to the phenomenon, the mechanism connection, the control system, the spool tremor, the rotation rotation and the spring compression were checked, but no abnormality was found, so it was judged that a certain valve disc fell off again. When disassembled, it was found that the V-valve stem fractured again, see detail Figure 6. Since the online valve beam was re-repaired during the first failure, so the valve beam assembly was replaced by warehouse-spare. After replacement, the compressor started again, the failure disappeared and turbine ran smoothly.

Figure 6. Fracture photo of V-Valve Stem

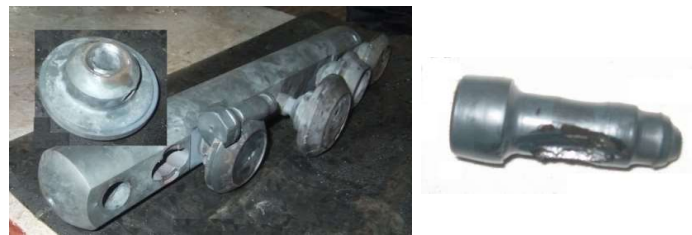
When the compressor ran for 3 months, the pressure of steam network had failure again because of GPF, the residual pressure of steam could not keep the compressor speed, so the compressor tripped on low-low flow interlock. While the steam system recovered, the compressor was restarted again, but it was found that the quick-closing valve opened and the speed-regulating valve closed, but the steam turbine speed rushed to 4000 rpm directly, the speed-regulating valve could not control the low-speed warm-up procedure. So it was judged again that a certain disc had fallen off. After disassembled, it was found that the IV-valve stem fractured, , See Figure 7. and the V-valve was checked OK by PT(Penetrant Testing), In order to recover the process as fast as possible, the repaired valve-assembly last time was replaced again, and the compressor parameters were normal after starting.

Figure 7. Fracture Diagram of IV-Valve Stem

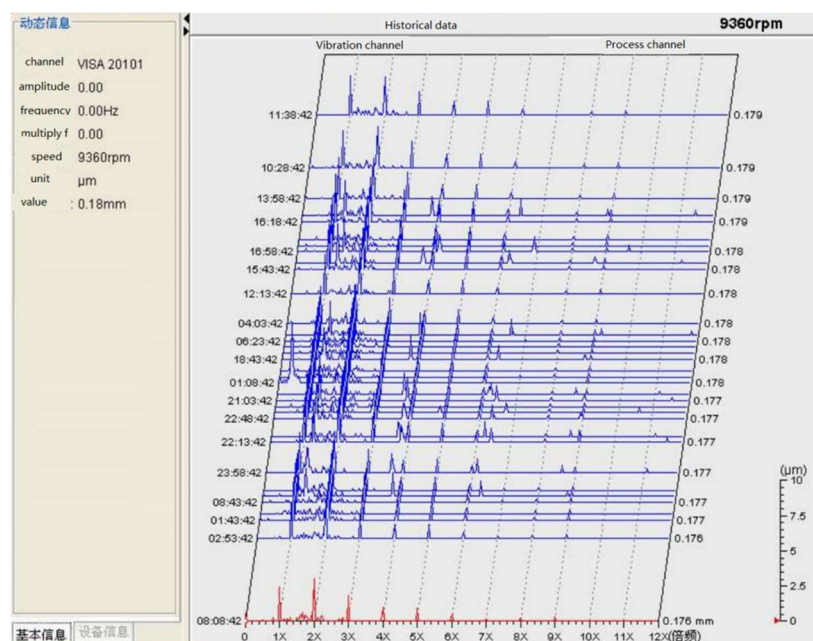
From the start-up vibration spectrum after each failure, the specific spectrum amplitude and total amplitude of discrete frequency were good, so it could be concluded that the influences of balance, alignment, loosening and friction problems can be ignored, see Figure 8 (the spectrum are almost same of each start-up).

Figure 8. Waterfall Spectrum of Turbine Bearing

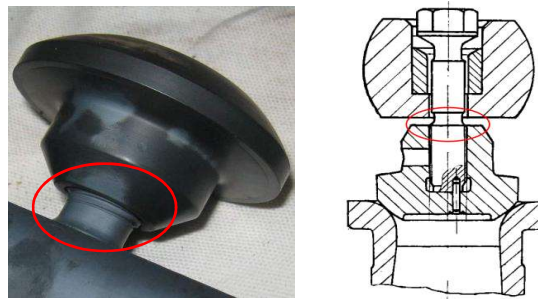
From the perspective of structure, the valve disc and the valve stem are connected through screw threads, the end of stem screw thread is the abrupt point of geometric shape, which will inevitably become a weakest point. When the valve-beam-assembly is subjected to external forces, the stress concentration of the screw thread starting point is apparent [2][3], see Figure 9. When there are machining defects in the tooth root of the screw, such as initial Crack Opening Displacement (COD), turning defects, excessive roughness, and too small transition angle of variable section of the screw will cause stress concentration. When the excitation force by steam is large, the gap between the rod sleeve and the valve stem will cause the valve stem to swing from side to side sharply, the cracks caused by vibration will occur at the stress concentration point. With the initiation and expansion of cracks [4], fatigue brittle fracture will eventually be happened[5]. This is the structural reason that the steam control valve stem always fatigue fractured in the same position which reported in many thesis [6][7][8][9][10][11][4].

**Figure 9.** Structure of Valve Disc Components

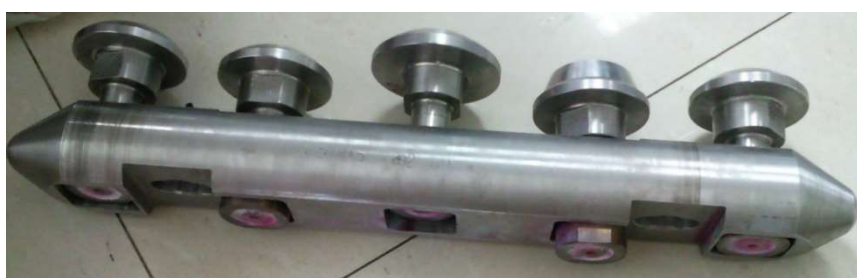
**Figure 11.** Improved Valve Beam Assembly

a. The valve disc and stem should be manufactured integrally, optimize the stem structure, strengthen the connection strength, and avoid the stress concentration caused by the necking-down of the stem;

- b. Increase the cone ratio of the windward surface of the end of the valve beam to enhance the guiding effect on the stem, optimize the positive impact force and flow field disturbance distribution of the steam on the valve beam assembly;
- c. Material of valve beam assembly use tempered stainless steel to improve the mechanical performance and fatigue resistance;
- d. Take a detailed Non-Destructive Testing of weak parts, especially corner point, eliminate steep corners to reduce COD eigenvalue.

With the next one month, the improved valve beam assembly was manufactured according to the requirements, see Figure 11. After replaced, the compressor was started-up and continued to run for four months, until the plant had a planned shutdown for turnaround. During the turnaround period, the components of the valve beam assembly were checked, and there were no abnormal friction, no abnormal cracks, etc.. Since then(3 years), similar problems had no occurred again.
