Dynamic Assessment of Geological Hazard Risk of Double-Track High-Risk Slope of Chongqing-Hunan Expressway

Shiyu Wu¹, Honggang Wu^{2,*}, Wei Li¹

¹Chongqing Yuxiang Double-lane Expressway Co., Ltd., Chongqing 401121, China

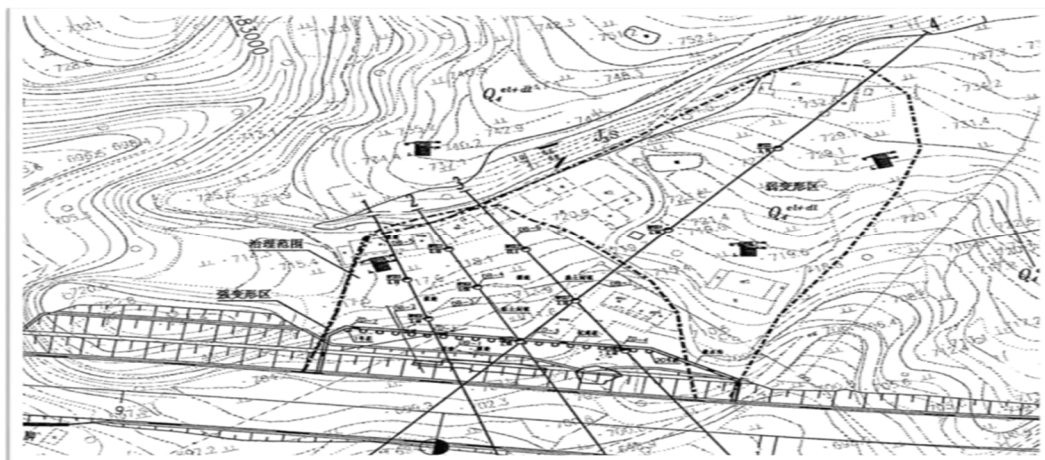
In November 2021, China Railway Yangtze River Transportation Design Group Co., Ltd. completed the "Yuxiang Expressway double-line Banan to Pengshui section K51 + 960 - K52 + 060 left side of the Waltaoping landslide disposal change design document", the report for the scale and stability of the Waltaoping landslide to develop a prevention and control plan, the plan is: set up $D = 2\text{m}$ circular anti-slide pile support on the back side of the primary slope, pile center spacing 5m layout, pile body using C30 reinforced concrete, pile after the pile set up a water interception ditch, Through the slope rapids groove into the roadbed ditch, the soil between the pile and the slope retaining wall is appropriately leveled and brushed after the gentle slope planting and greening protection.

Figure 2. Distribution map of landslide control project

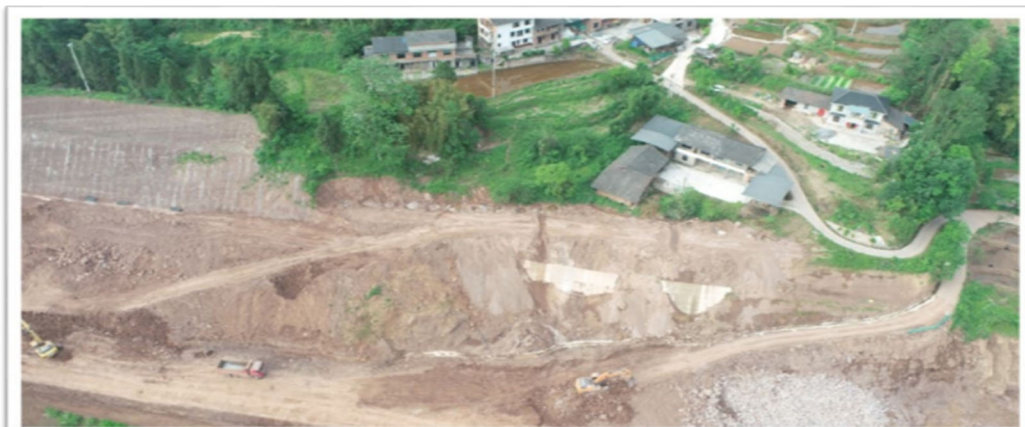
During the pre-flood dynamic assessment and investigation of the high-risk slope, the construction of anti-slide piles was completed, with a total of two circular anti-slide piles ($D=2\text{m}$) installed. Following the post-flood survey, the slope and drainage works associated with the landslide control project for the anti-slide pile construction were largely finished; however, grass planting and greening protection had not yet been implemented. An on-site investigation revealed that after the landslide treatment, the original cracks in the slope had not worsened, and there were no indications of new deformation.

Figure 3. Photographs of slope construction during the pre-flood survey

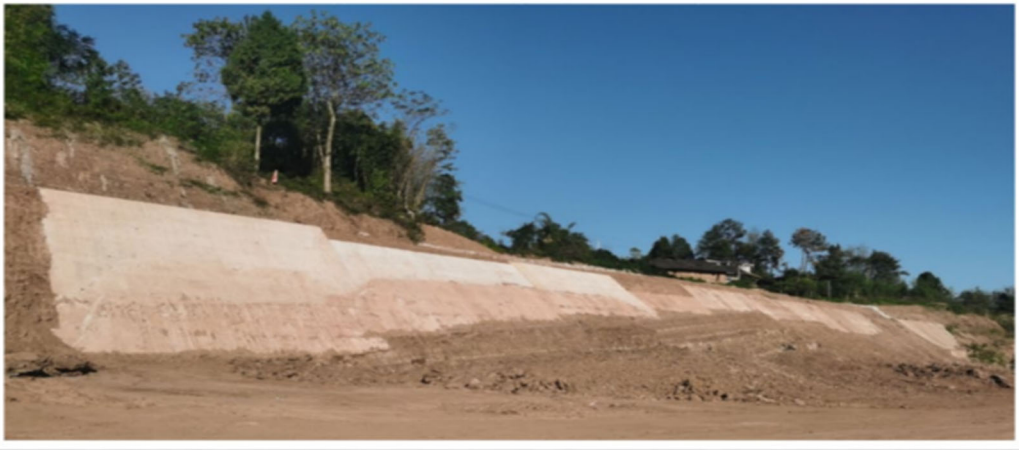
Figure 4. Photographs of slope construction during the post-flood survey
