# Fault Diagnosis and Maintenance of the Front Lighting System of Volkswagen Magotan

Study the front lighting system of the Volkswagen Magotan B8L model, analyze the composition and control principle of high beam, low beam, and side marker lights in the front lighting system. Introduce typical fault cases of high beam, low beam, and side marker lights, analyze fault phenomena, conduct fault diagnosis, and achieve fault elimination.

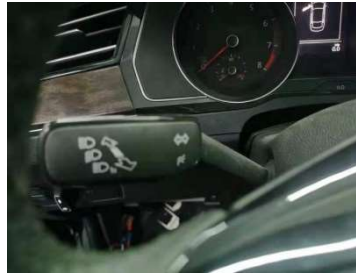
**Fig.1** Composition of Dimmer Switch

Under normal circumstances, the light rotary switch is turned to the low beam position, and the dimmer switch is pressed down, as shown in Fig. 1. The switch is internally connected to the high beam control contact, and then the steering column electronic device control unit J527 receives an analog signal to turn on the high beam. The control unit J527 converts this analog signal into a digital signal, and sends the data to the onboard power grid control unit J519 and the combination instrument control unit J285 through the comfort system CAN bus, J519 turns on the high beam lights, and J285 turns on the indicator light of the high beam lights (the actual measured indicator light of the high beam lights on J285 is blue).
